**SAS Superstructure**

**Daily Diary Report by Bid Item**

Contract No.: 04-0120F4

Diary #: 120 Const Calendar Day: 660 Date: 30-Jun-2011 Thursday

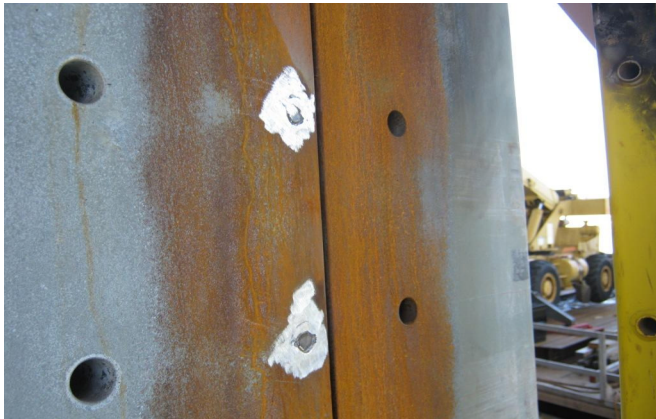
- 2 new barrels of weld wire were brought to the site and connected.
- Near the 9m diaphragm, 2 bolt holes were only about 12mm from the edge of the weld joint. To ensure that the weld does not burn through, they drive drift pins into the holes, and then ground them flush so as to not interfere with the cooling shoes. - See attached photo.

Bolt holes next to weld joint filled with drift pins

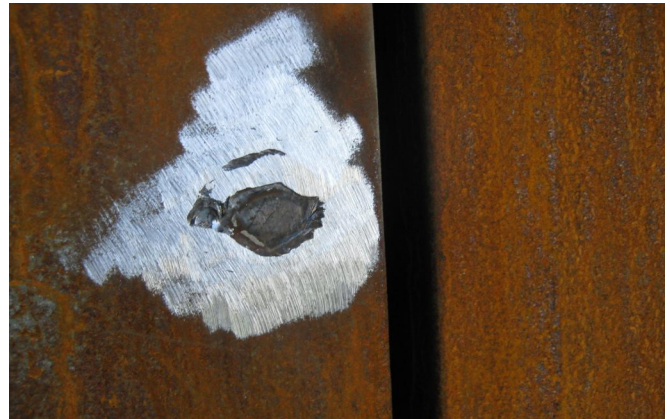
Close-up view of drift pin in bolt hole next to the weld joint
